CRASH TESTING OF VARIOUS TEXTURED BARRIERS

DEPARTMENT OF TRANSPORTATION
ENGINEERING SERVICES
MATERIALS ENGINEERING AND TESTING SERVICES

September 2002

1. REPORT NO. FHWA/CA/TL-2002/03	2. GOVERNMENT ACCESSION NO.	3. RECIPIENT'S CATALOG NO.	
4. TITLE AND SUBTITLE CRASH TESTING OF VARIOUS TEXTURED BARRIERS		5. REPORT DATE September, 2002

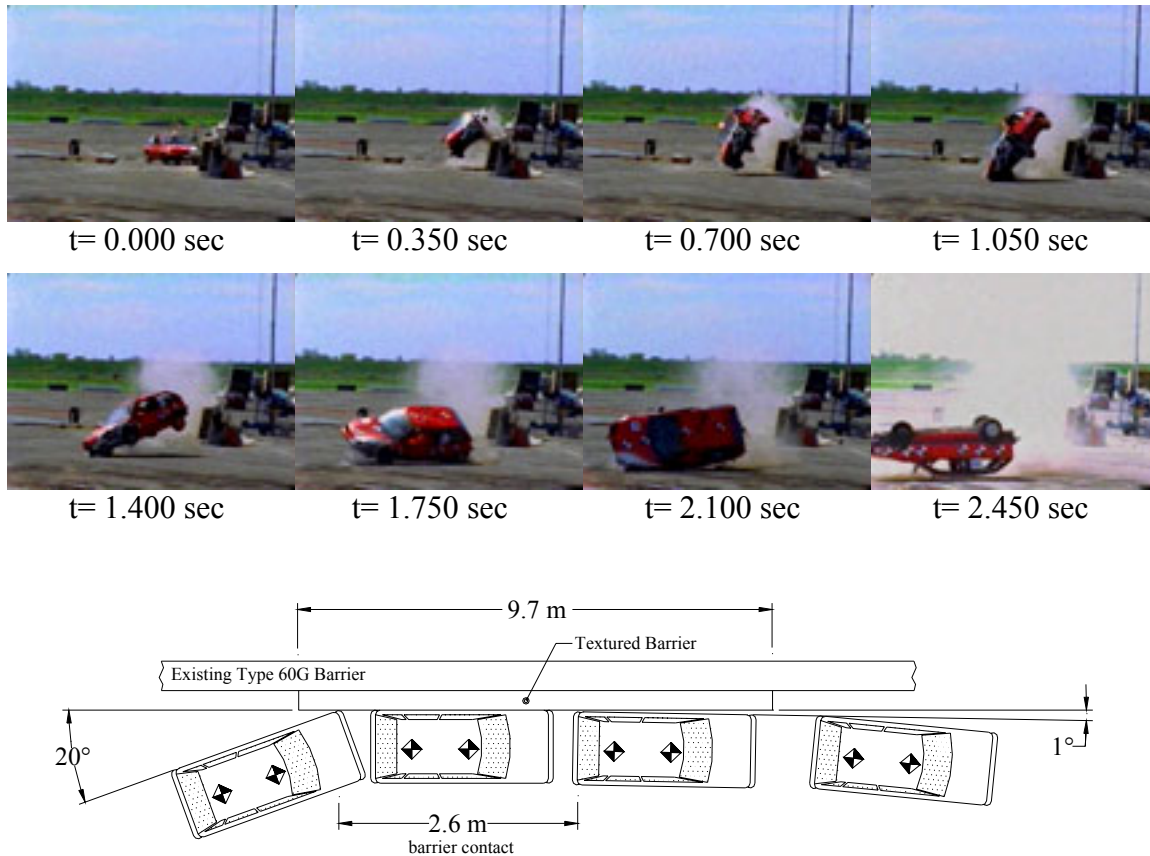
Figure 2-16 Impact sequence and diagram for Test 582

Barrier Damage: Several of the 19-mm deep flutes were broken and knocked off of the face of the barrier. The vehicle left scrapes and gouges as it climbed to near the top of the barrier.

Many of the concrete flutes along the path of the wheel assemblies were broken away at their base (i.e. where they meet the solid surface of the barrier). The typical length of each of these broken sections of flute was about 175 mm. The barrier could remain in service and would remain crashworthy until repairs could be implemented. Repair times for this barrier would be lengthy due to the extent of the damage and geometric nature of the pattern.

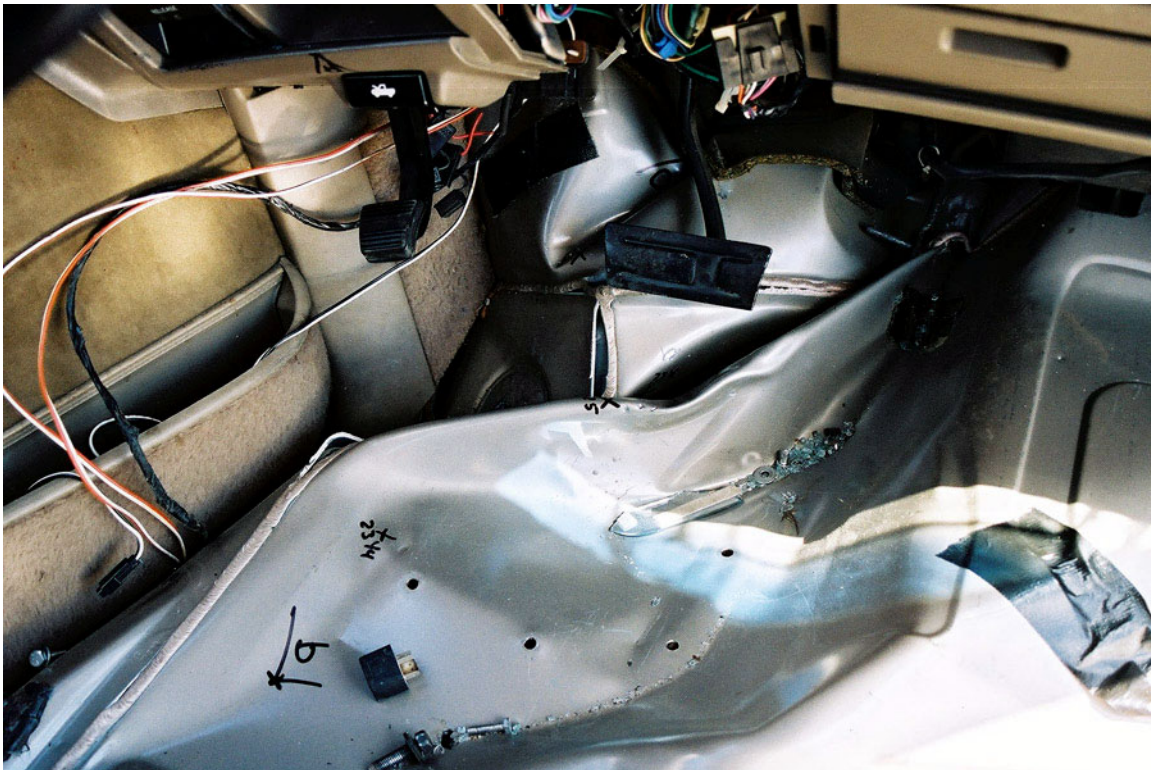
Figure 2-24 Vehicle floorboard deformation after Test 583

The left front corner of the vehicle was substantially damaged in the initial impact with the barrier. The left side of the vehicle also had significant scraping and the door was pushed rearward. The driver-side door remained latched even though the top window frame portion was buckled outward from the cab roof by 250 mm. The left front bumper and left fender were pushed rearward and inward. The left side tires were deflated but the right side tires remained inflated. The left front wheel assembly was pushed rearward enough to cause excessive deformation of the driver's side floorboard area (Figure 2-24). This amount of deformation exceeded the upper limit of 150 mm which has been informally proposed by the FHWA and is generally accepted by the roadside safety community.

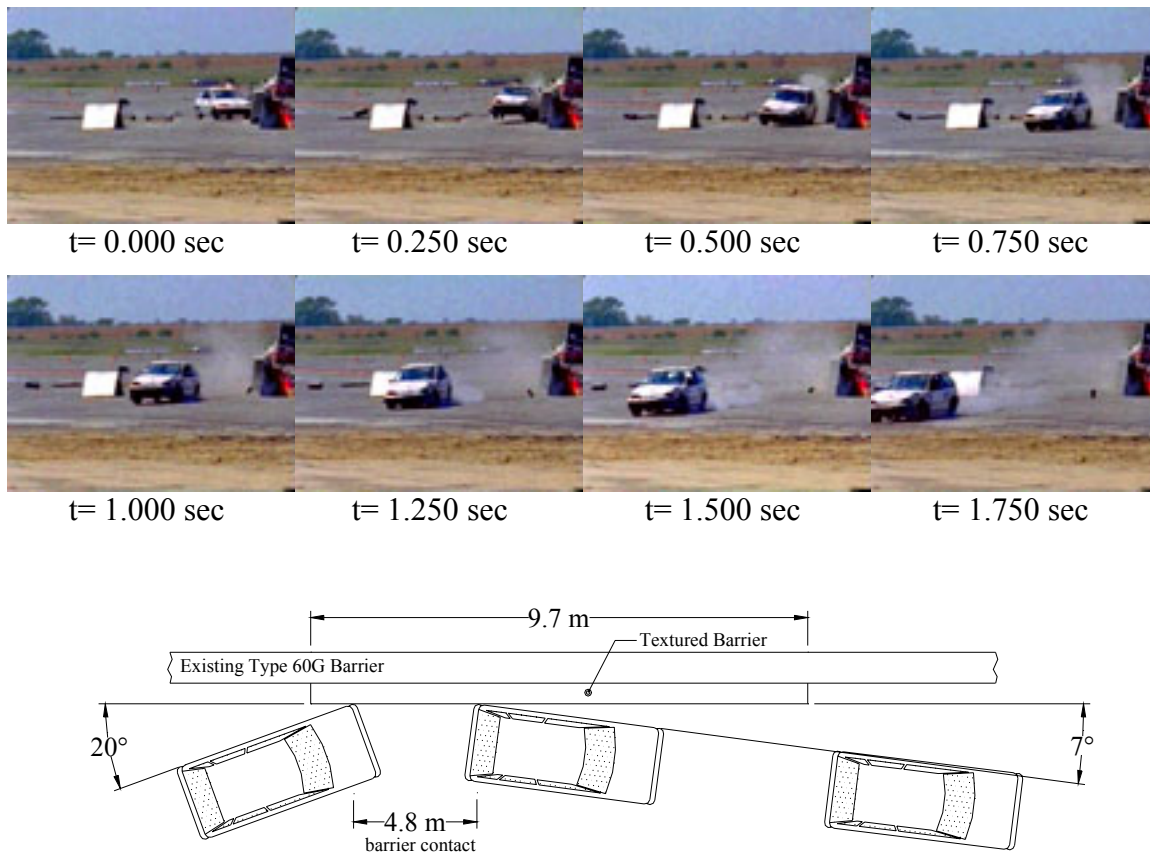
Figure 2-31 Impact sequence and diagram for Test 584

Barrier Damage: Very minor scraping of the sandblast surfaces. No chipping or gouging was observed. The barrier would not require immediate repair.

There was essentially no permanent damage to the barrier. The vehicle caused only minor scrapes to the concrete surface of the barrier. The barrier would not require immediate repair.

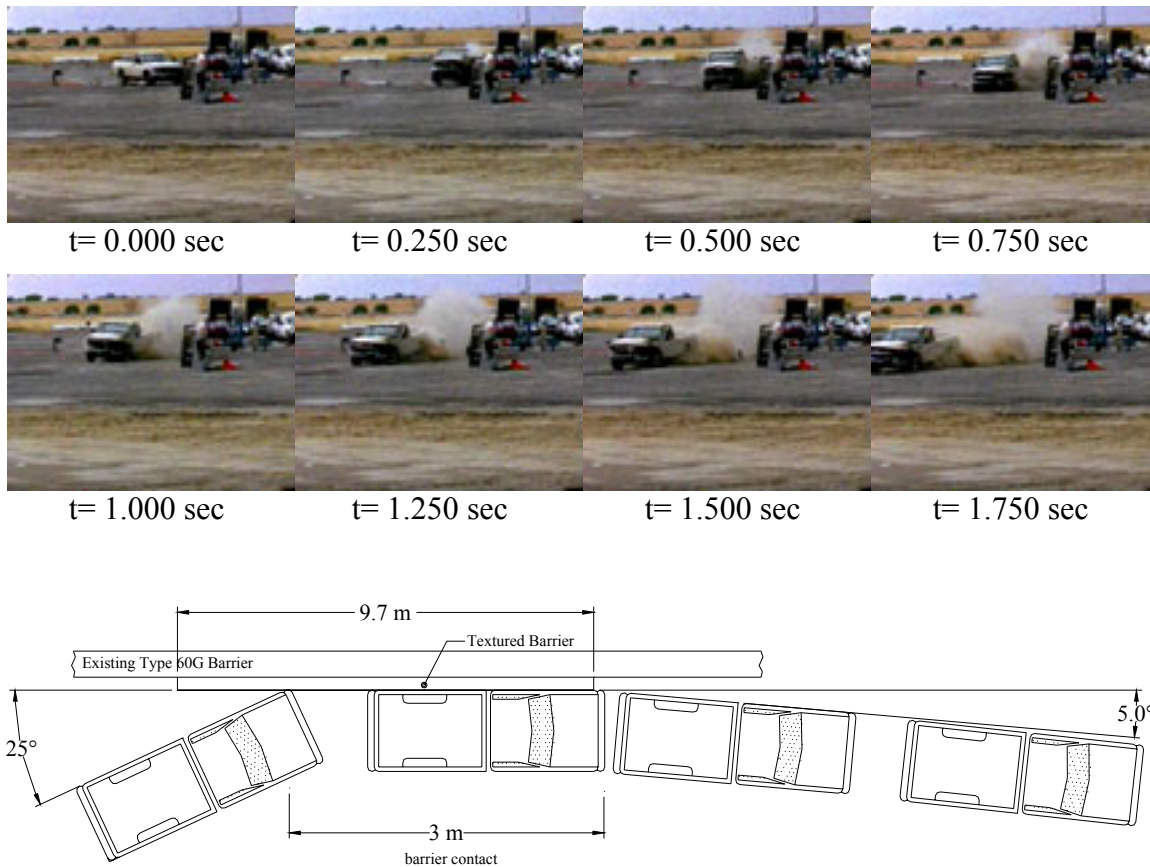
Figure 2-37 Impact sequence and diagram for Test 585

Barrier Damage: Very minor scraping of the sandblast and cobblestone surfaces. No chipping or gouging was observed. The barrier would not require immediate repair.

There was essentially no permanent damage to the barrier. The vehicle caused very minor scraping of the sandblast and cobblestone surfaces. No chipping or gouging was observed. The barrier would not require immediate repair.
